Re: Hoggs Lane, bridge over Black Brook

I write regarding the bridge over the Black Brook on Hoggs Lane¹ and its urgent need for maintenance.

Hogs Lane bridge, need for maintenance

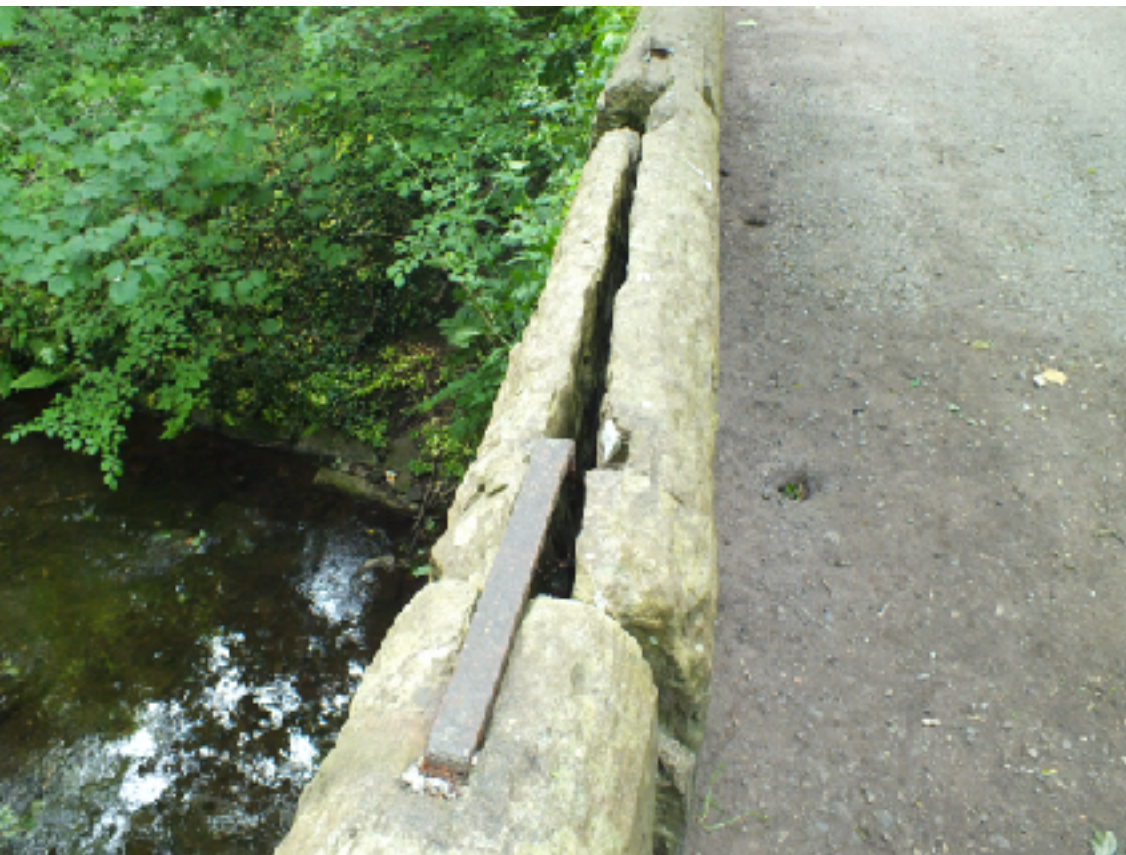
Current state: The bridge is still in extremely good condition overall with much of the pointing strong and intact and the key stones showing no sign of movement. However, some of the parapet stones are in poor condition and are in need of urgent maintenance to consolidate the split stones and prevent further deterioration. One centre stone is in a very

weak state and could easily fail if subject to abuse (*Image 4 and 5*). Previously, at least 50 years ago, two split stones on the upstream side were strengthened with bolts (*Image 6 and 7*). The bridge is a popular place for young children to play Pooh sticks with a rush from the upstream side of the parapet to the downstream side (with the weak stone) to see the sticks floating by. I am fearful that the parapet could fail at such a moment leading to a potential tragedy. Additionally some sink holes have appeared on the downstream side of the bridge near the centre, directly above where the utilities: gas, water and electric pipes and cables that feed both number 2 and number 4 lie. (*Image 8*). Some careful excavation and recovering of these would be advantageous. Additionally during heavy rain storms, water runs off the A6, down Hogs Lane and finally runs into the Black brook, by the side of the bridge and has come with such force that a small valley has been cut into the soil and on occasion the torrent has exposed the utility supplies to both mine and Mr. Heaton's home (*Image 8*). Mr. Heaton, my Father and I have covered these up with rubble that eventually washes away. A better solution with thick steel anchored into ground such that the services would be protected from the torrents and retain cover over the pipes/cable is needed.

Image 4. Split parapet on the down stream side. Note how the parapet stones were held by steel which was held in place with lead. The bottom side is till good, the upside has failed.

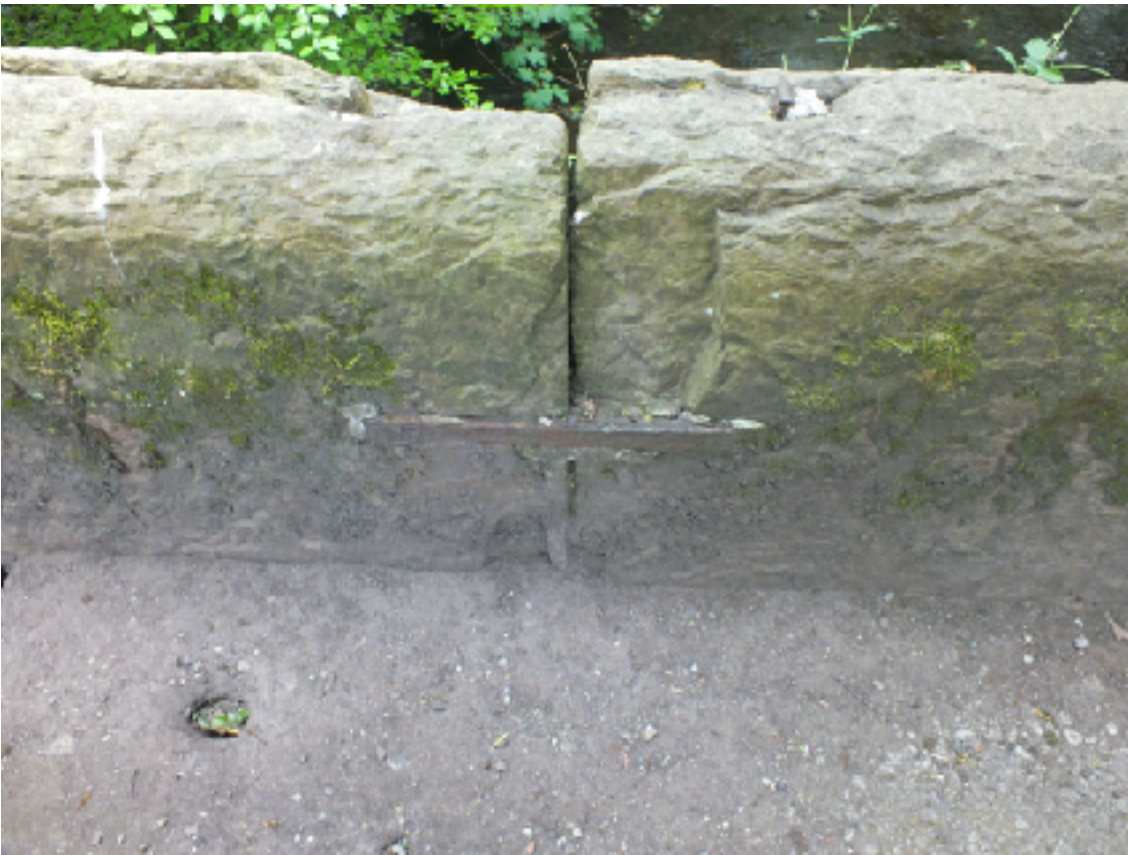
Image 5. The parapet stones were also held by horizontal steel bars. This one is still holding whereas the top steel had gone, just a small piece of steel is on the right hand side.

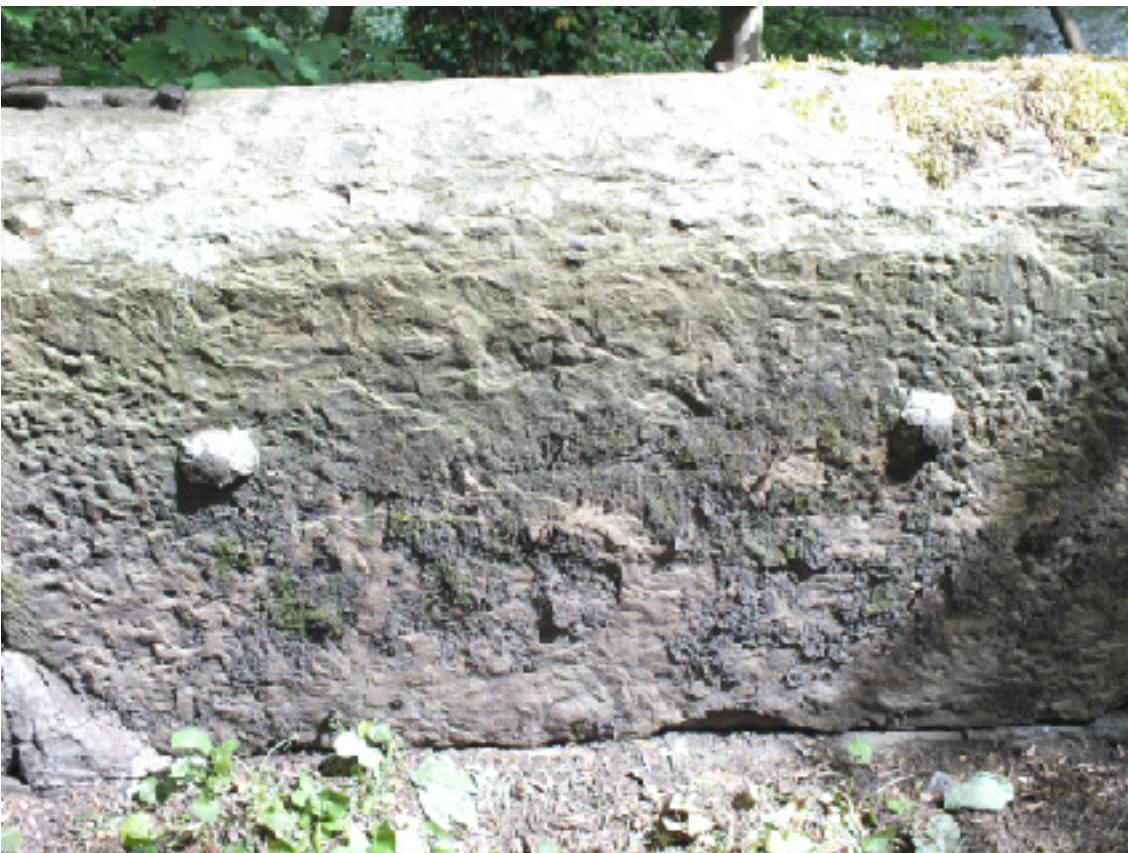
Image 6 Lane side of a spit parapet stone on the upstream side held together with two bolts
Hoggs Lane bridge, need for maintenance

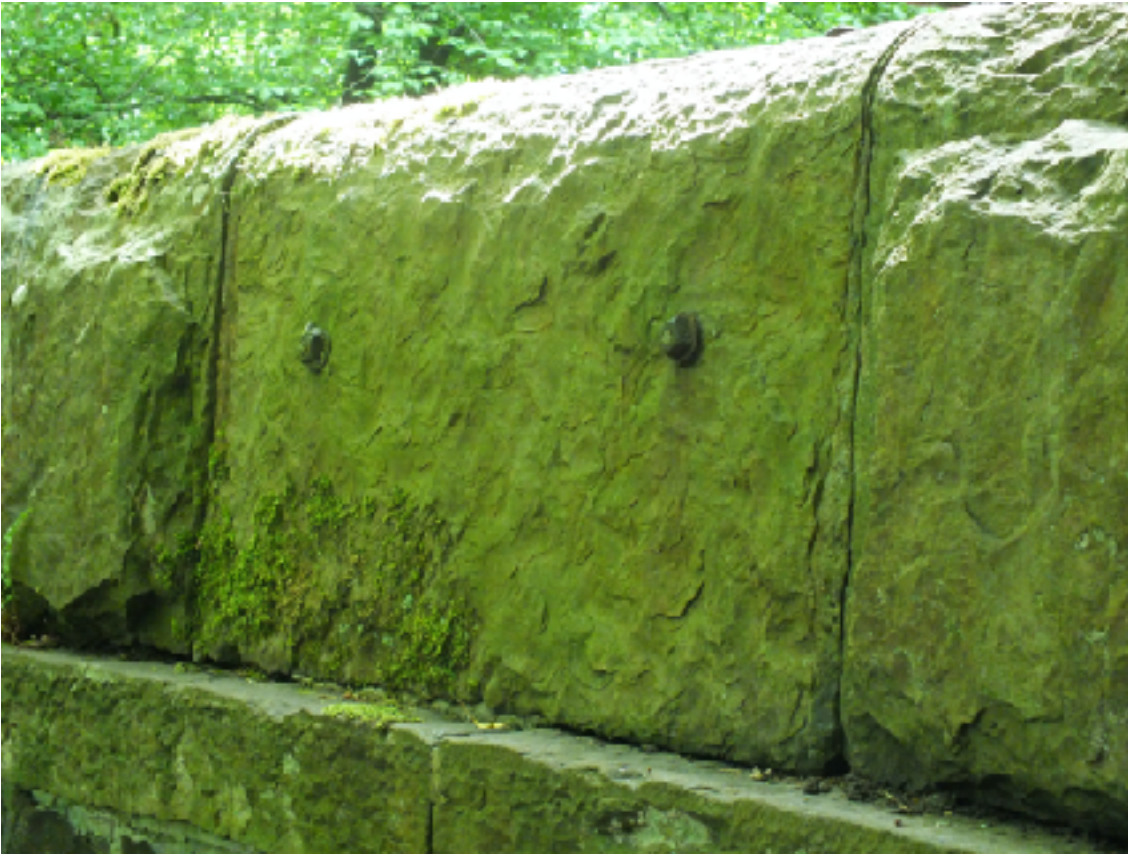
Image 7 Water side of the split parapet stone showing nuts on bolts

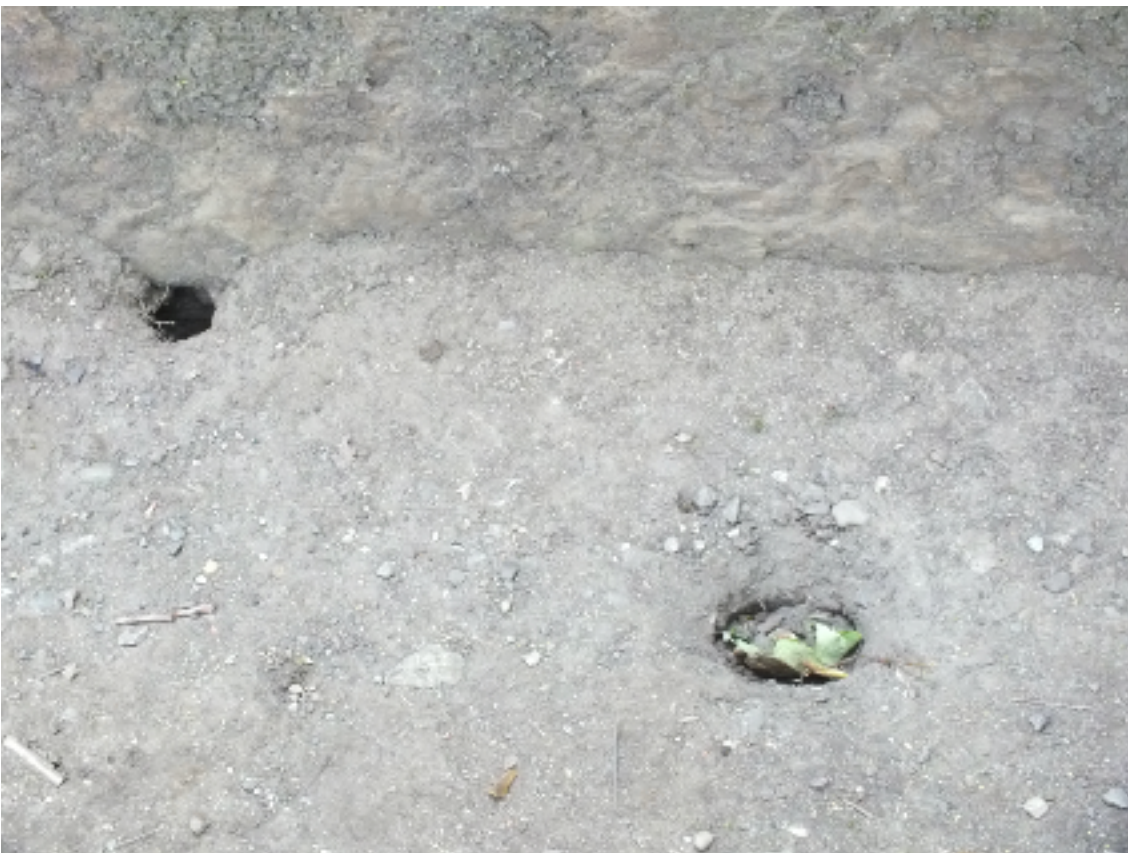
Image 8 Two of the four sink holes over the utility supplies for 2 and 4 Springwood Cottages

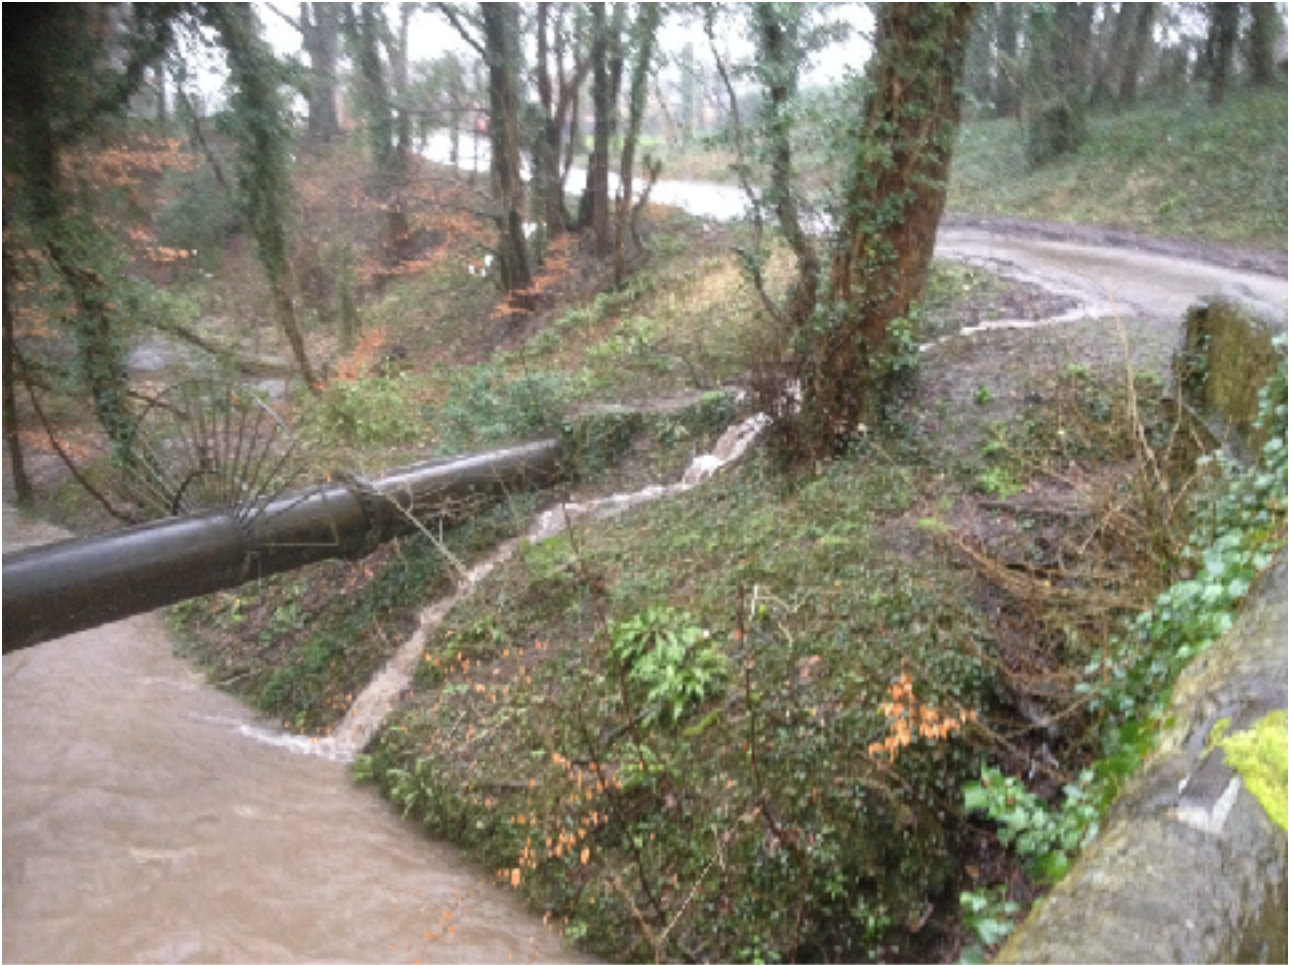
Image 9. Storm water running off the A6 and down Hoggs Lane. This is the most recent exit to the Black Brook, but on many occasions the storm water has come down by the side of the bridge, cutting the valley shown next to the bridge and exposing utility supplies at the top.
