Re: Hoggs Lane, bridge over Black Brook

I write regarding the bridge over the Black Brook on Hoggs Lane¹ and its urgent need for maintenance.

Hogs Lane bridge, need for maintenance

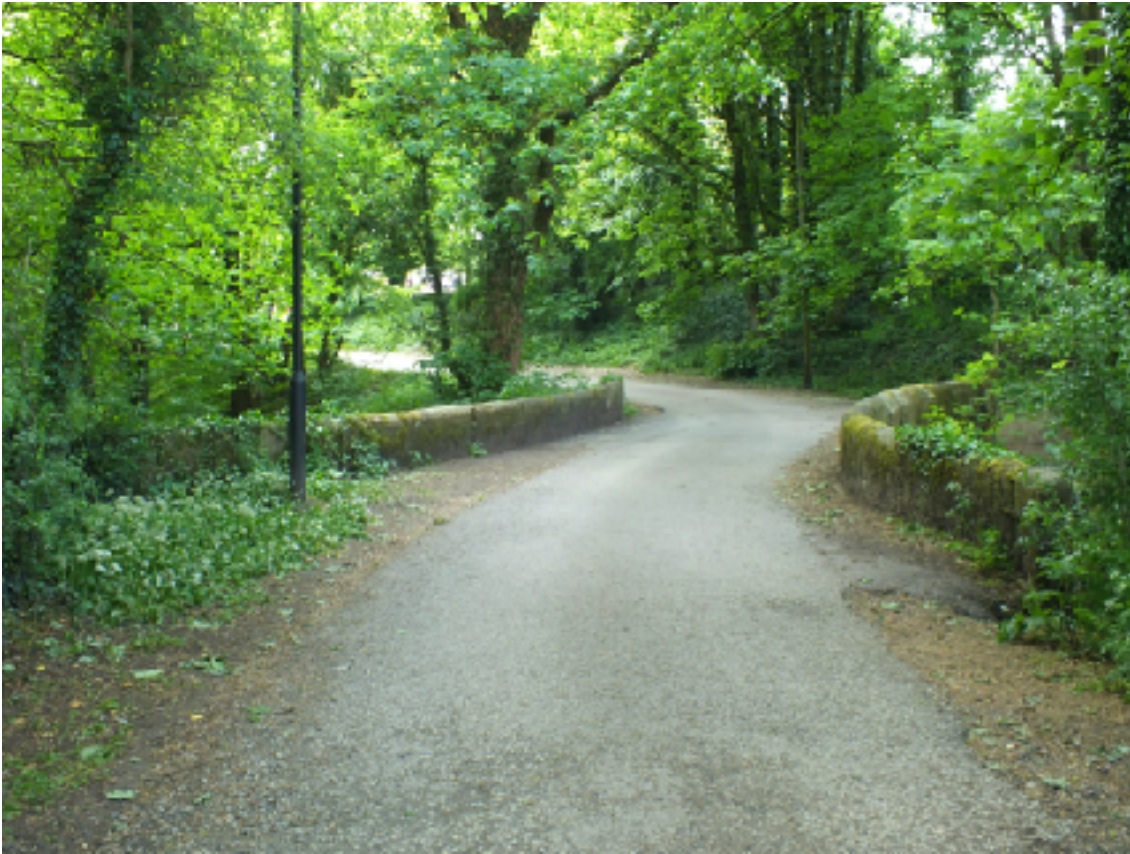
Location: The bridge (*Image 1*) is on Hoggs Lane spanning the Black Brook, and is reached by turning off the A6 at the end of Albany School railings when travelling towards Bolton.

Image1, View of the Bridge on Hoggs lane, towards the A6

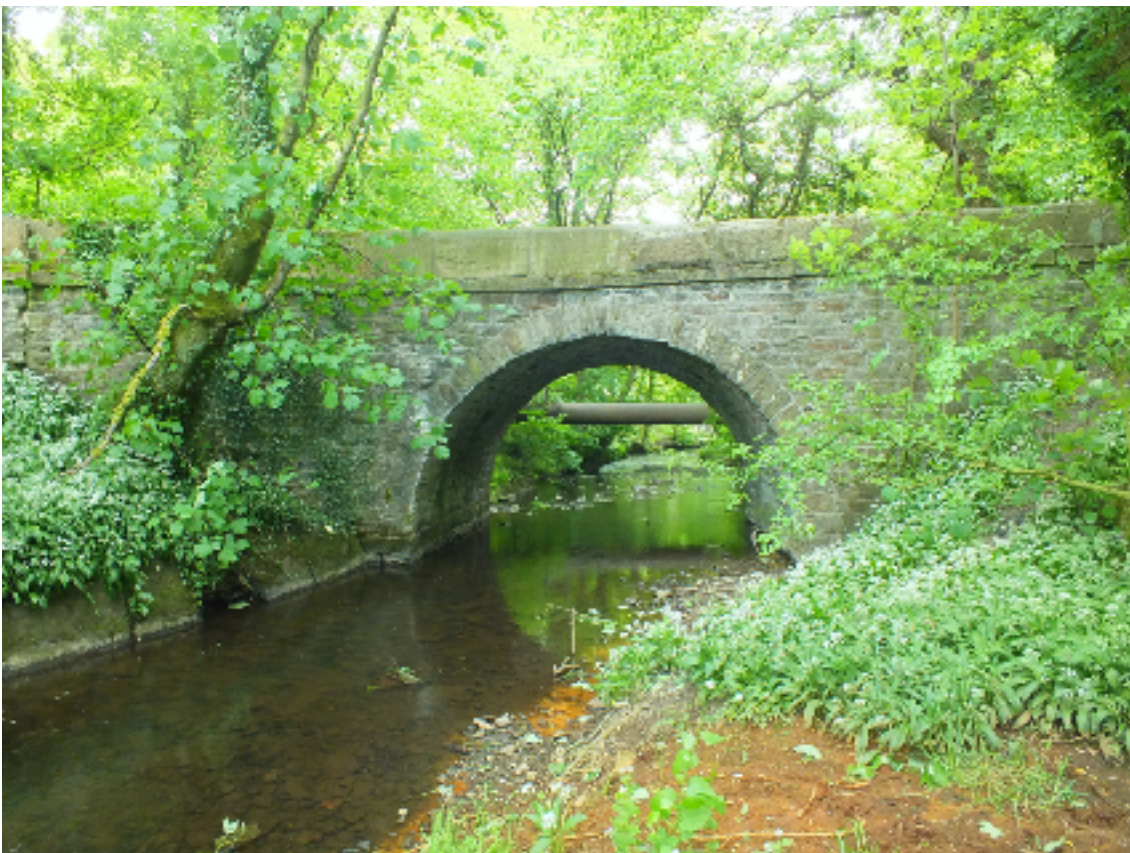
Construction: & Age The Romanesque style bridge (*Image 2 and 3*) was constructed, I believe before the 1840's which is the approximate date of construction of my house (2 Springwood Cottages), and its semi detached partner (4 Springwood Cottages) owned by Mr. Gordon Heaton. However, there is a bridge across the Leeds Liverpool canal which feeds down Hoggs lane and as this canal was opened in 1774 and the bridge over the canal has many similarities with that over the Black Brook the bridge could be older. As far as I know the bridge is not listed.

Image 2 View of the bridge, upstream side.

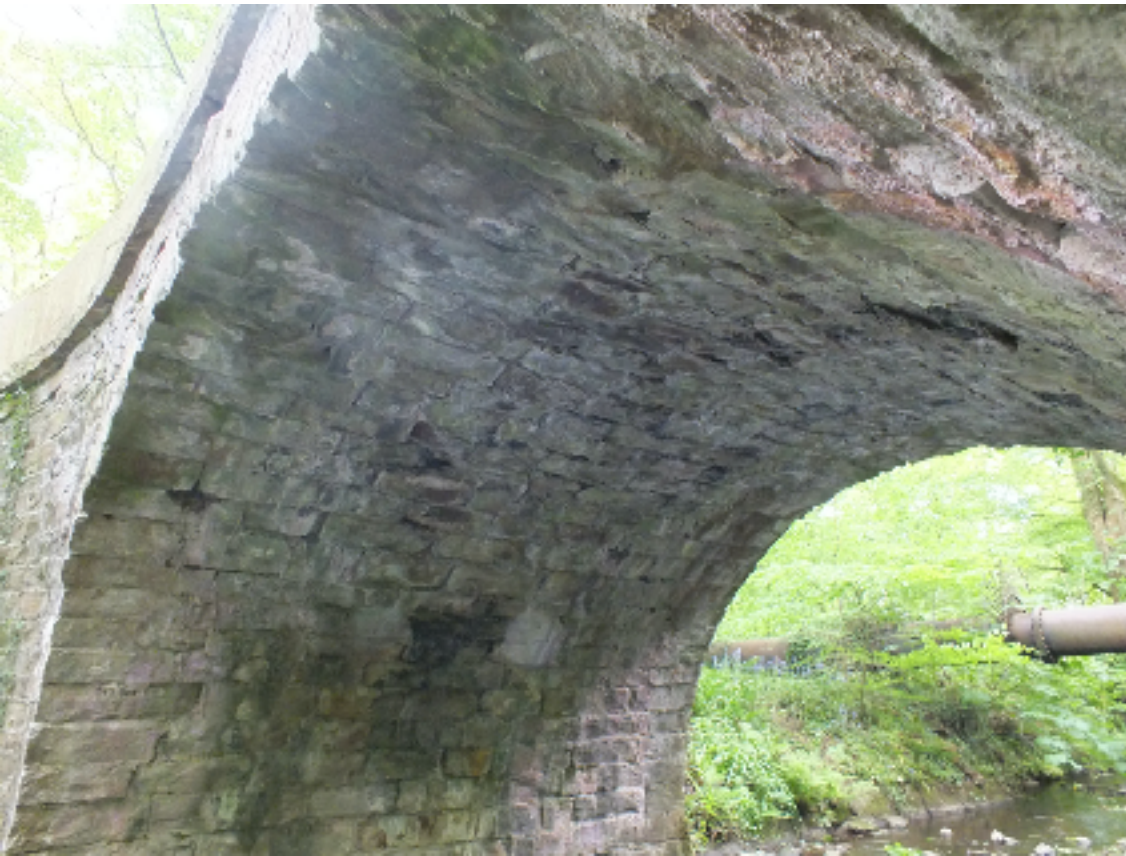
Image 3 Underside of the bridge
